ASK 13
Flight Manual

Flight - and Maintenance - Manual
for the Glider
AS - K 13
Edition

.....
Serial No. 13050

ASK 13
Technical Note
No. 14

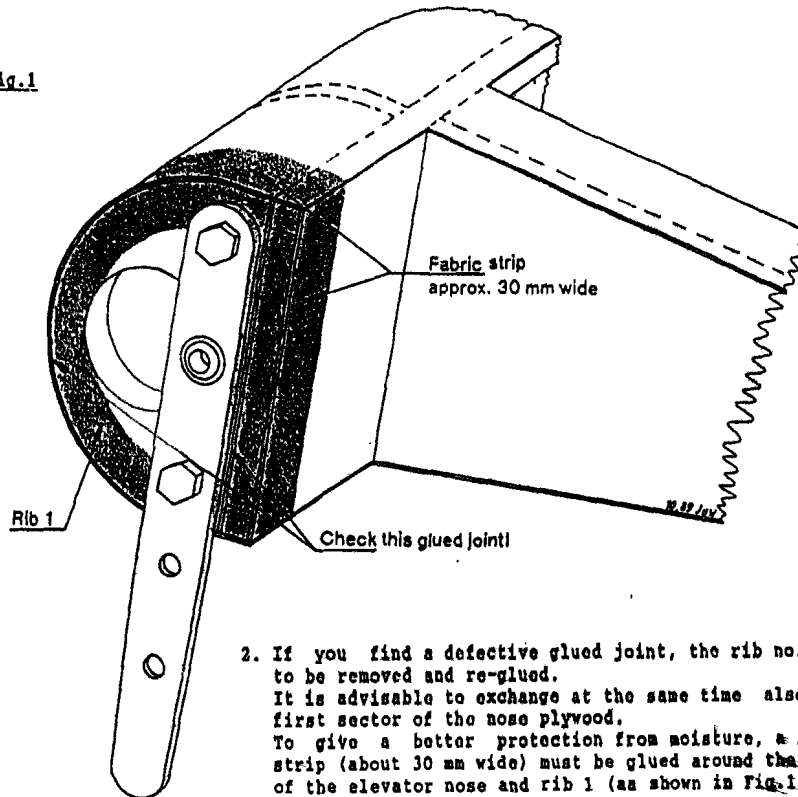
Fig.1

A glider of the model K7 failed to gain normal flight attitude immediately after tow rope release on winch launch. With the stick full back only the left elevator could be actuated in the correct direction; the right elevator deflected downwards. The reason for this was a loose glue bond at the elevator rib 1 at which the elevator fitting is attached. Similar incidents lead already before to the issue of the LTA 72-7 dated Feb.9,1972.

1. Remove elevator.
Check that the glued joint between rib 1 and the leading edge plywood and the elevator spar respectively is in good condition (see Fig.1). Before doing so check whether the LTA 72-7 of Feb.9, 1972 was already previously accomplished (this is not applicable to K9, K11 and ASK 18); if yes then the fabric strip first carefully has to be detached in order to be able to check the glued joint.

Loose glue joints on rip 1 of the elevator

2. If you find a defective glued joint, the rib no.1 has to be removed and re-glued. It is advisable to exchange at the same time also the first sector of the nose plywood. To give a better protection from moisture, a fabric strip (about 30 mm wide) must be glued around the edge of the elevator nose and rib 1 (as shown in Fig.1).
3. The above action under points 1. and 2. must be repeated every three years during the annual re-inspection. This copy of the Technical Note must be inserted in the Flight and Operations Manual of the respective glider as an annex and a corresponding entry must be made into the "Amendments to the Manual".

Rib 1 made from multi-plywood, 15 mm thick, and nose plywood, 1 mm thick, according to DIN L 182/183, class 1/2 or NL 9128, 6.1013. Drawing as above.

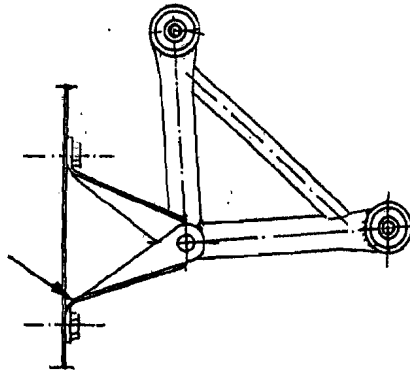
Material & drawings:

On some gliders of the model ASK 13 the bearing brackets of the airbrake control circuit have broken at the wing root rib. The failure was caused by too high toggle forces which resulted from a wrong adjustment of the toggle in the airbrake control circuit.

1. Carefully inspect the bearing brackets of the airbrake control circuit at the wing root ribs as well as the root ribs themselves for damage, cracks etc. In case of doubt the paint must be removed off the bracket. In most cases the breaks were found at the bottom of the front bearing bracket; refer to the drawing on Sheet 2 of this TN !
Where damages at one bearing bracket are found, this part must be exchanged; where a root rib is damaged, it requires repair.

2. Check the toggle force as described under Point 3.) and where necessary adjust.
3. Adjustment Instructions For Airbrake Toggle
 - 3.1 Undo the airbrake return spring at the front operating lever in the cockpit.

- 3.2 The airbrake toggle - each side separately - must be adjusted such that a force of approx. 3 to 4 daN is obtained at the front airbrake operating lever when measured from above (measurement distance from the pivot point of the operating lever towards the hand grip = 300 mm).

- 3.3 Adjustment of the toggle force is done by turning in or out the adjusting heads in the fuselage. If the correct adjustment values cannot be achieved here, the thickness of the airbrake stop blocks inside the wings must either be increased or cut back.

- 3.4 Take care that the toggle must not go over the dead point which would cause the airbrakes to extend again.
- 3.5 For both airbrakes together, the hand forces must not exceed approx. 6 daN, when measured at the front airbrake operating lever from above.
- 3.6 Re-fit the airbrake return spring at the front operating lever in the cockpit.
4. This Technical Note must be inserted as appendix into the ASK 13 Flight and Maintenance Manual and this action must be entered into the "Amendments" on page 2.
5. The inspection of the bearing brackets and of the toggle force of the airbrake control circuit (as described under points 1. thru 3.) must be included from now on within each annual C. of A. inspection.
